## Merafong pollutes river

## **Khutsong residents ‘living in a danger zone’ amid sinkholes and sewage**

## REPORT ON ONGOING SEWAGE POLLUTION - WONDERFONTEINSPRUIT

## SITE VISIT ON THE 24<sup>TH</sup> OF APRIL, 2024

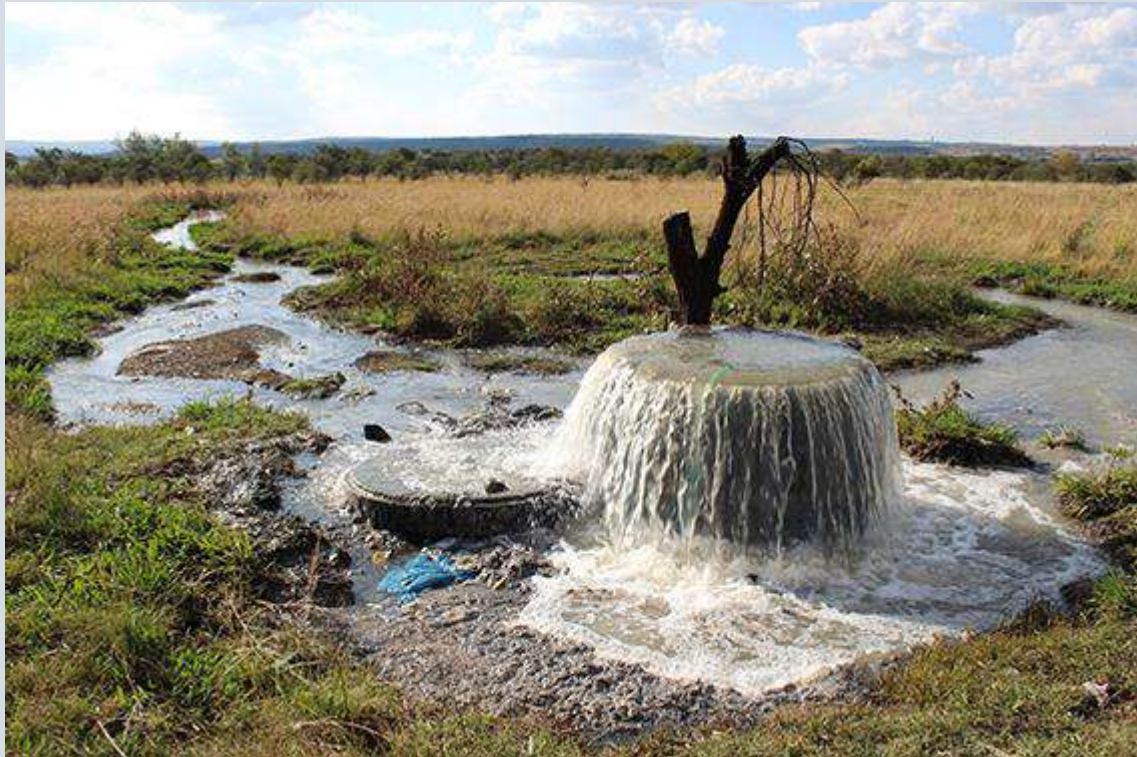
Thousands of litres of sewage flow from a maintenance hole between Kokosi and the Merafong City Local Municipality's sewerage works.

Currently, so much sewage flows from the industrial-sized sewer hole that one can hear the roar from one side of Kokosi.

The force of the flow has pushed the heavy concrete cover aside. It is now lying in a river of sewage close by. All the sewage flows towards the Loopspruit.

“The problem is caused by the construction of the Kokosi plant. It will be resolved within a month. A project is underway to connect the new outfall sewer to the Kokosi waste water treatment plant. We continuously test and monitor the downstream water,” says the municipal spokesperson.

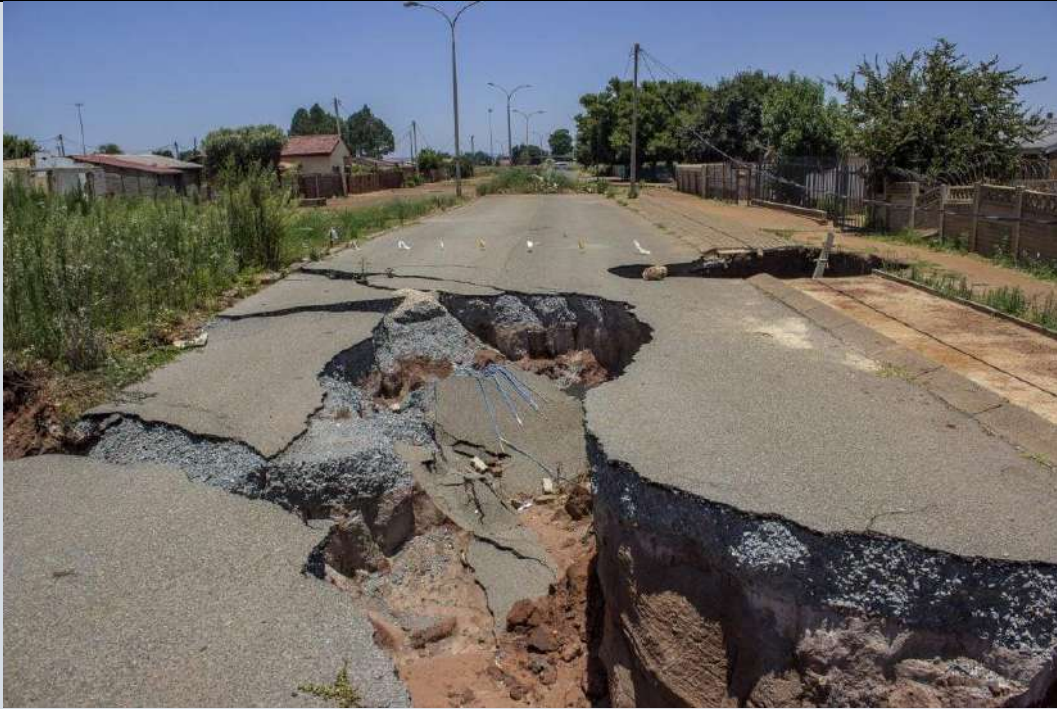
Foul-up: Sinkholes swallow roads in Khutsong. Photos: Delwyn Verasamy

Jerry Ramokgoatedi, a founder of the Khutsong Dolomite Risks and Vulnerability Community Support Group, says pervasive sewage pollution by the Merafong City local municipality has worsened the crisis. Blocked, leaking and cracked pipes have allowed sewage to flow into the dolomitic bedrock, creating more sinkholes.

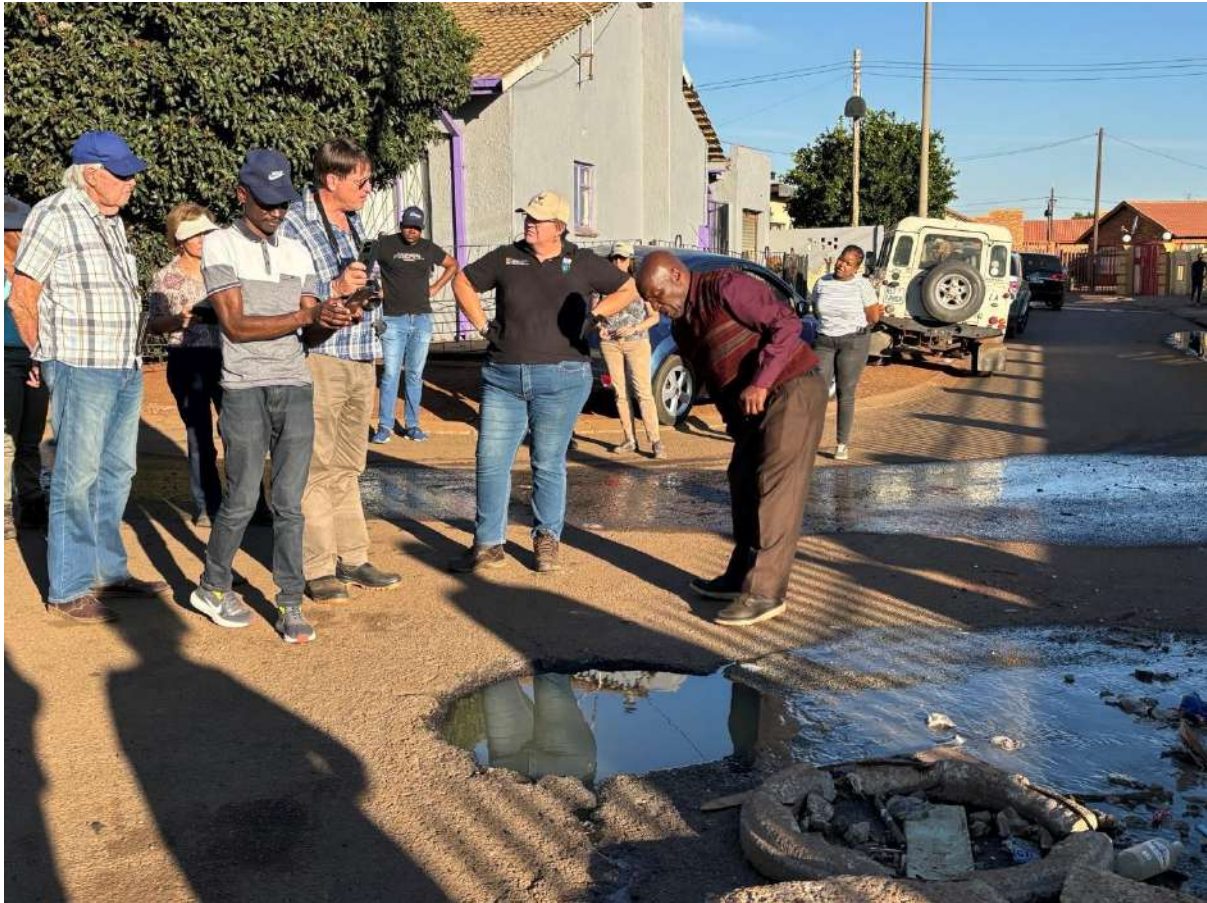
Mr Jeremiah Ramokgoatedi, Ms Anet Muir, Prof Richard Meissner, Mr Dennis Jane and others at an open manhole in Khutsong. (Photo: Prof. Anja du Plessis)
